Manhole Inspection Summary

Manhole # S13EE1017MH

Location Address: **2820 QUANTICO AVE**

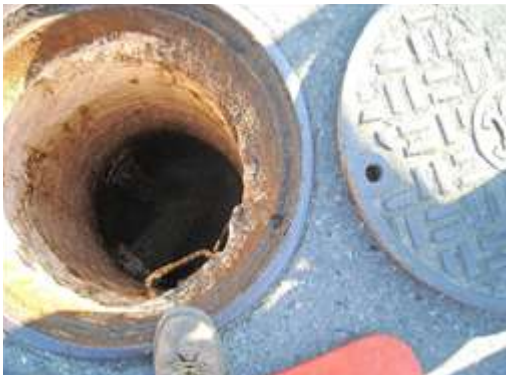
Defect 3

Offset: **2** (in.)

2" FRAME OFFSET

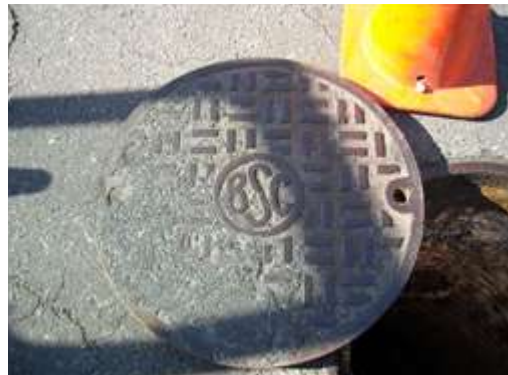
Defect 2

Condition: **Worn**

WORN COVER

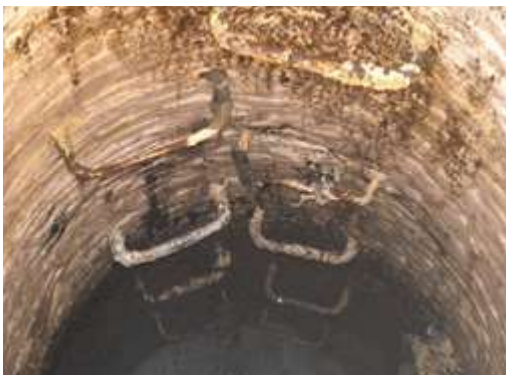
Defect 1

Count: **9** Missing: **0** ☒ Corroded

☒ Evidence Of Surcharge

Depth: **4** (ft.) ☐ Active Surcharge Present

CORRODED STEPS AND EVIDENCE OF SURCHARGE

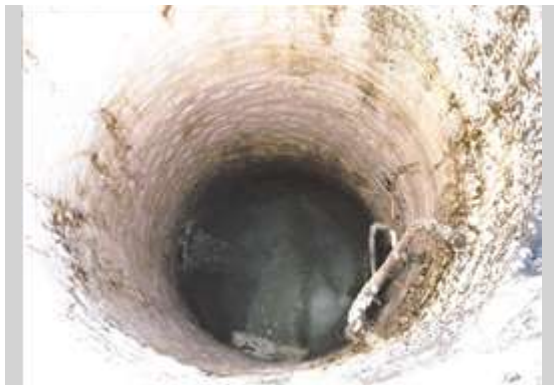
12 O'Clock Outflow

IMPOSSIBLE TO CAPTURE PIPE
CONNECTION PICTURE WITH POLE
CAMERA DUE TO VELOCITY OF FLOW

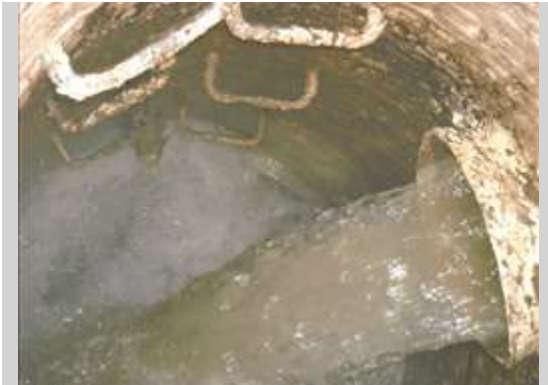
5 O'Clock Inflow

IMPOSSIBLE TO USE POLE CAMERA TO
TAKE PIPE CONNECTION PICTURE DUE
TO VELOCITY OF FLOW

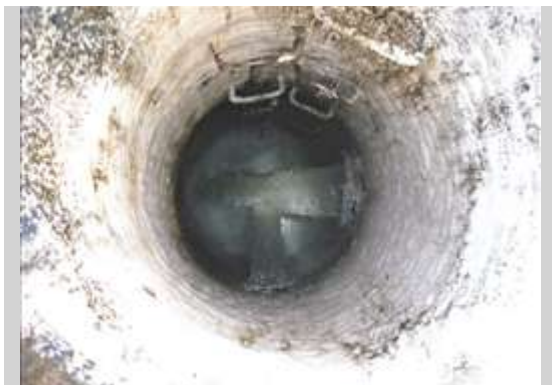
6 O'Clock Inflow

IMPOSSIBLE TO CAPTURE PIPE
CONNECTION PICTURE WITH POLE
CAMERA DUE TO VELOCITY OF FLOW

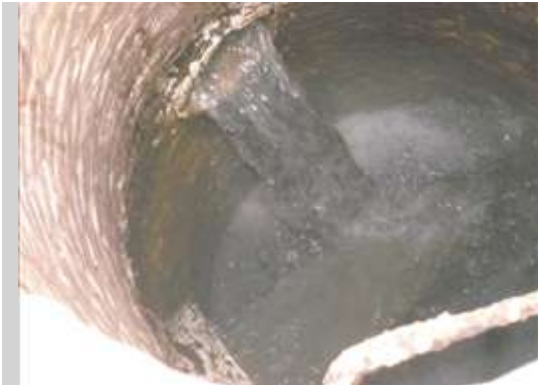
9 O'Clock Inflow

IMPOSSIBLE TO CAPTURE PIPE
CONNECTION PICTURE WITH POLE
CAMERA DUE TO VELOCITY OF FLOW

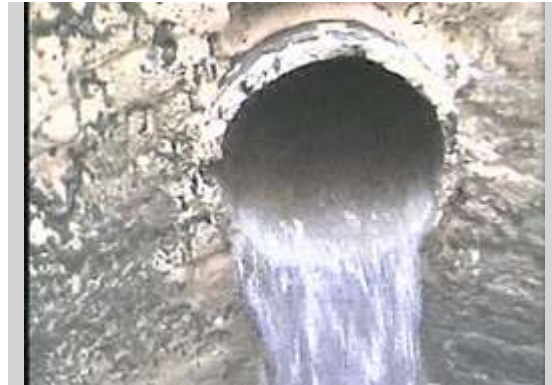
NOTE HEAVY FLOW
